Esophageal nitinol stent dysfunction because of fracture and collapse

Endoscopy 2009; 41: E170–E171

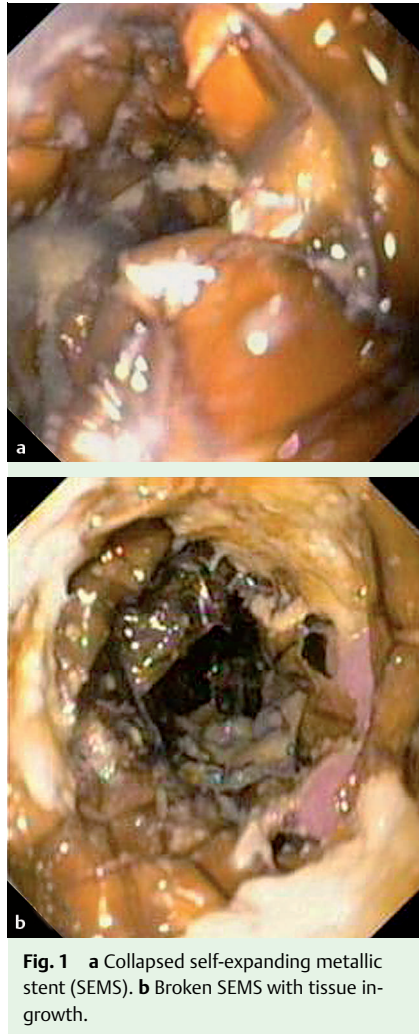
Fifteen months later, the patient reported back with progressively increasing dysphagia. An upper gastrointestinal endoscopy revealed that the SEMS had collapsed at places, and the wire mesh was broken with ingrowth of tumor (● Fig. 1). Under fluoroscopic and endoscopic guidance, a 14 cm nitinol SEMS (Choo stent, M. I. Technical, Seoul, South Korea) was placed within the previously placed stent (● Fig. 2).

Fig. 1 a Collapsed self-expanding metallic stent (SEMS). b Broken SEMS with tissue ingrowth.

cause of late fractures of the esophageal stent. Other causes could be thermal overstrain induced by laser application, or defective material at the time of deployment or spontaneous fracture [2–5]. As the present patient survived for a long period after insertion of the first stent, the corrosion caused by prolonged presence of the SEMS in the esophagus could have caused it to collapse.

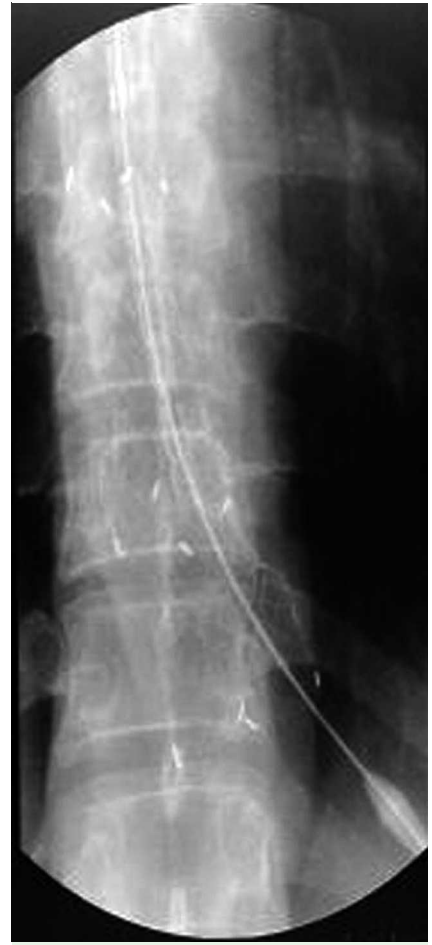
Fig. 2 Deployment of a new self-expanding metallic stent (SEMS) over the collapsed SEMS.
